CHURCH of ST. ANDREW.  
BRIGSTOCK.  
ANGLO-SAXON ARCH,  
to tower/nave.

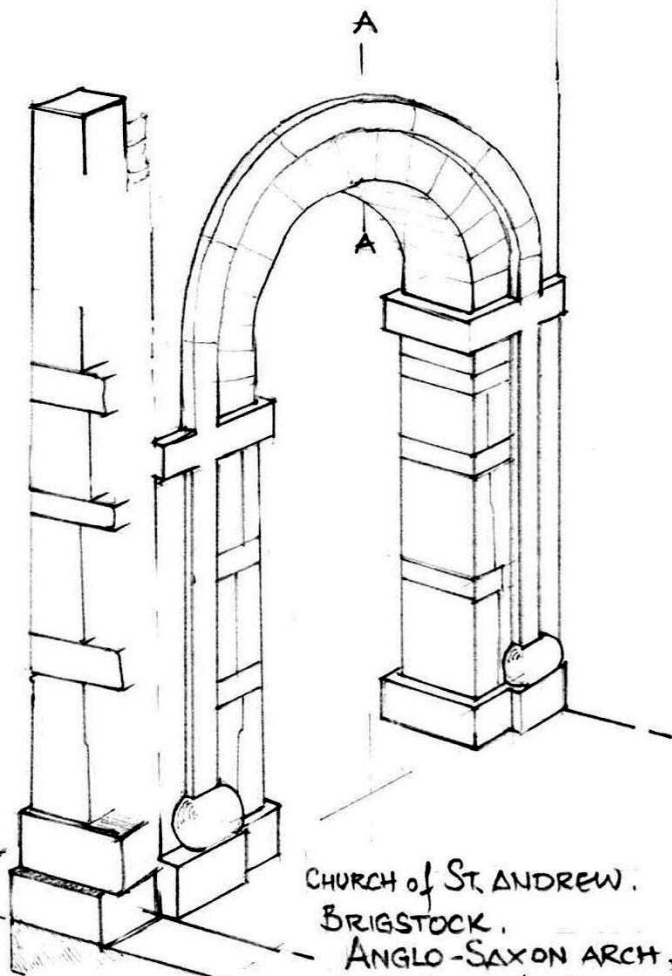
roughly coursed rubble walling.

Above: section AA  
Hood moulding.

S.W. QUOIN L&S WORK,  
shown in relative  
(actual) position to archway.
