## All Saints Church, Brixworth, Northants.

A remarkable early building comprising varying stages of alteration over the centuries and possibly begun in the last quarter of the 7th C. Internally the nave and presbytery were separated by a wall pierced by 3 arches, this having been removed and replaced with a 15th century pointed arch.

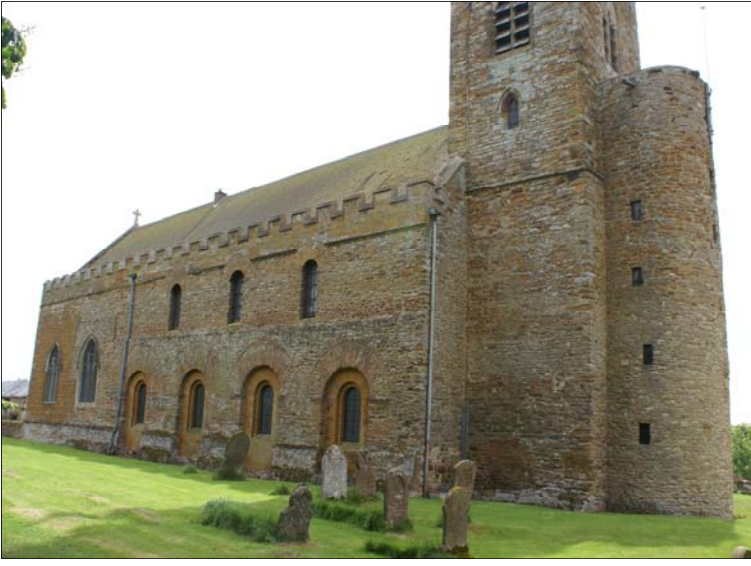
- Clockwise from top left -
1. The exterior from the north aspect.
  2. The interior of the nave looking west, showing the now blocked arches which originally led to a series of 'porticus' or side chapels.
  3. The west wall of the nave in more detail, showing the doorway above cut through by the 10th c. triple window above that.
  4. Doorway in south wall of tower, originally Roman to S annexe. Note the reuse of Roman bricks in the arch, so evident everywhere in this building.
  5. South aspect of tower (built over west porch), and half-round stair-turret.
  6. The east end of the (present) nave showing the archway to the chancel (chancel rebuilt and restored in the 19th cent.)
