The church of St Martin, Canterbury.

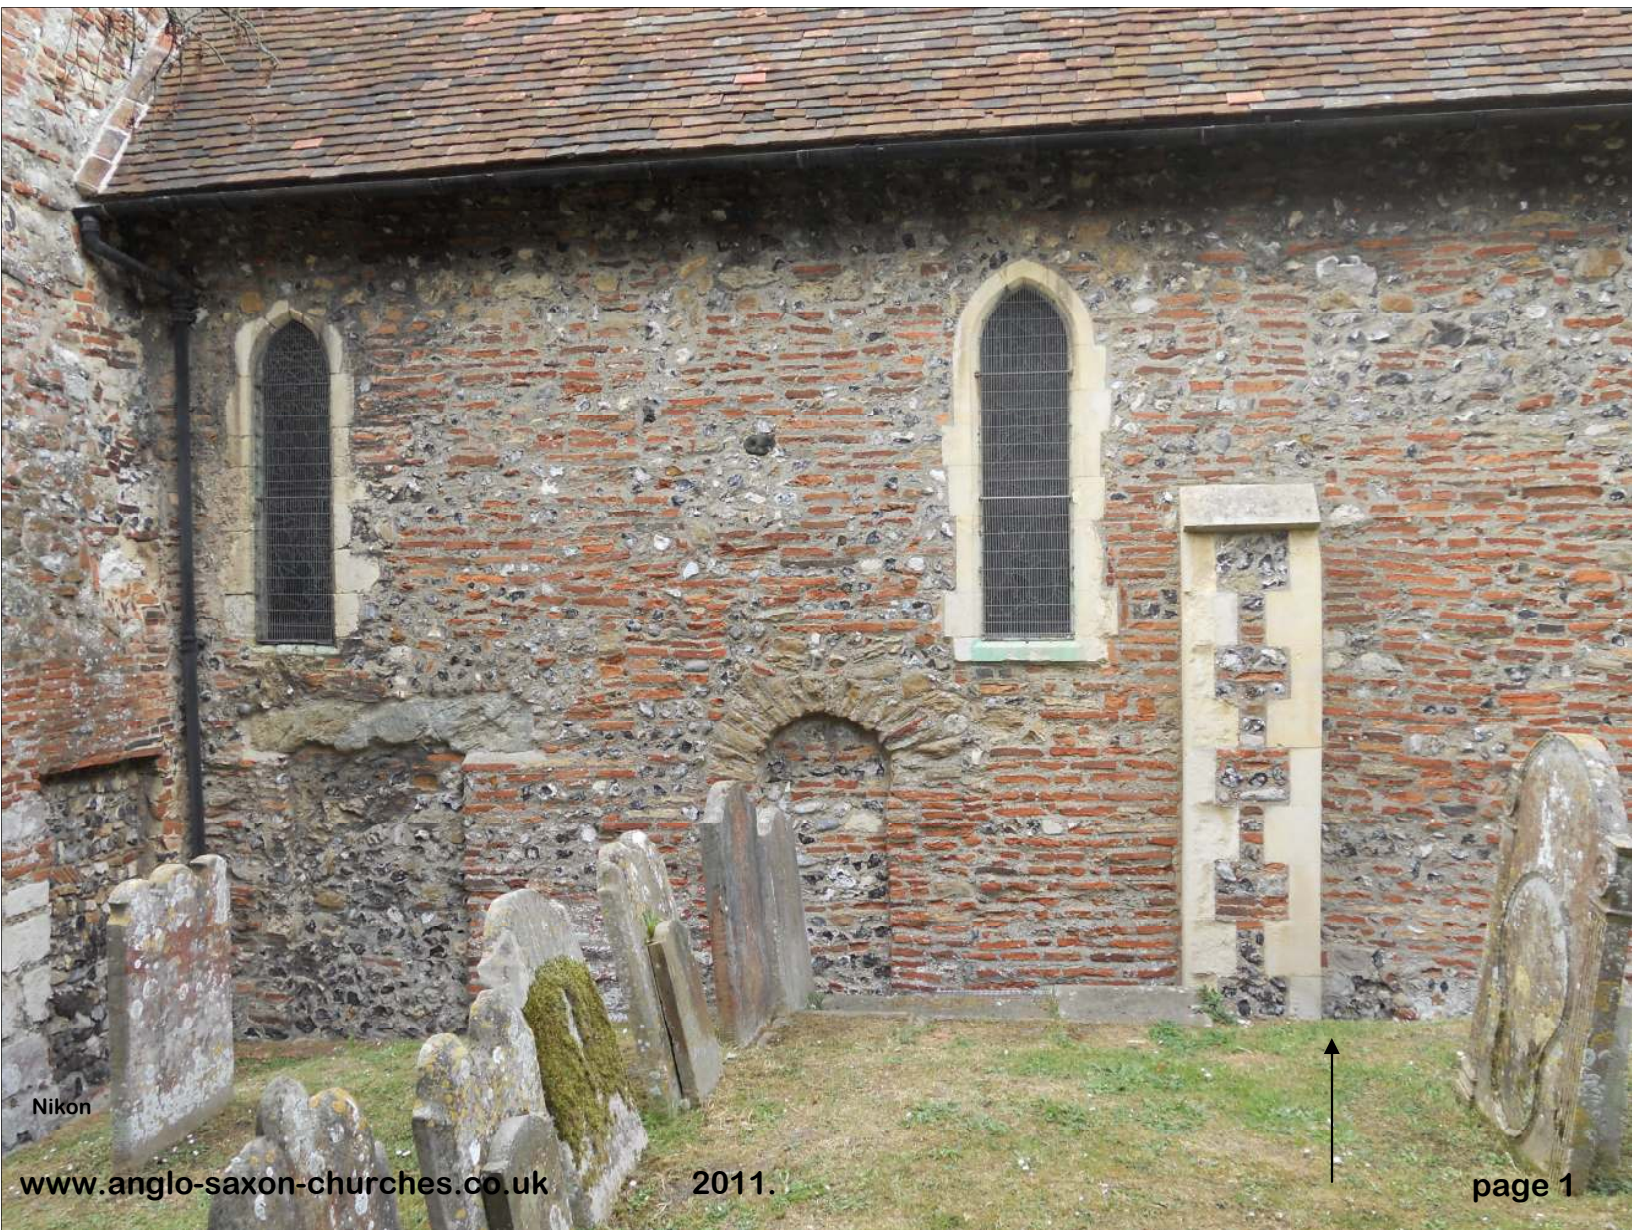
1. The western portion (half) of the south wall of the chancel. The later extension lies to the right. Part of the Anglo-Saxon nave is to the left just in picture. Taylor states that this western portion of the chancel once extended further west than it does at present, and this was the nave of the church referred to by Bede, in which queen Bertha worshipped. The later medieval extension of the chancel has swept away and overlays the original eastern end, and the present nave has destroyed the western portion of the old nave (now chancel). The square headed doorway (blocked) to left originally led to a very small porticus, foundations were described by Taylor, and those of its west wall are overlain by that part of the existing nave. In the 1895 and 1900 excavations an area of *opus signinum* flooring was discovered besides the doorway, together with considerable parts of the side walls running south from the chancel. The blocked round-headed doorway to its east is of a later date and is an Anglo-Saxon insertion, possibly belonging to the same date as the nave. H. Taylor puts the eastern extent of the 'first' nave where I have placed the black arrow. See picture 5 on page 2 for a more easterly change of walling. We should bear in mind that during the time before the Conquest this building was subjected to many alterations.

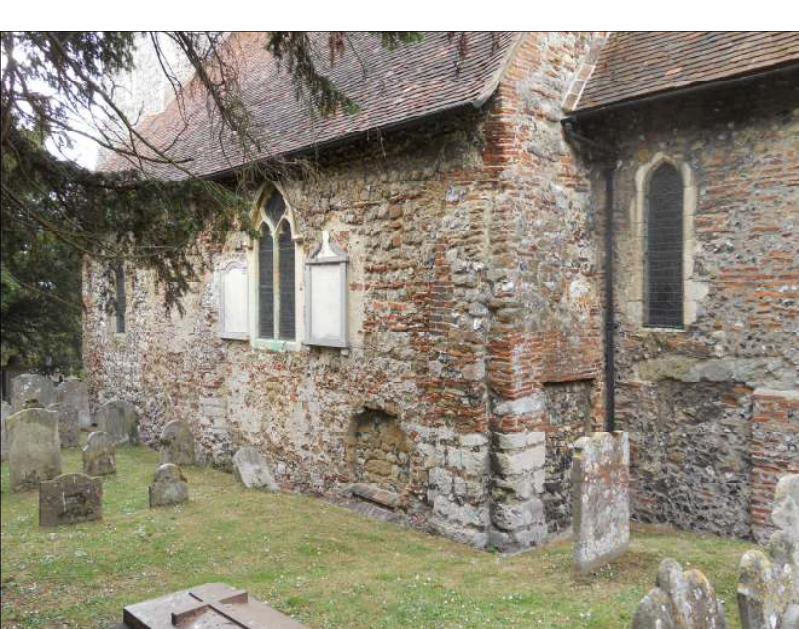
2. Seen to the right is the square headed doorway (previously described) in the chancel wall, and running to the left is the south wall of the nave. Comparing the make up of the nave walling with that of the chancel in picture 1 it is seen that the former is of a very different character, the Roman bricks are used not in regular courses as in the old chancel but rather with single bands of brick that are neither continuous across the walls nor even horizontally laid.

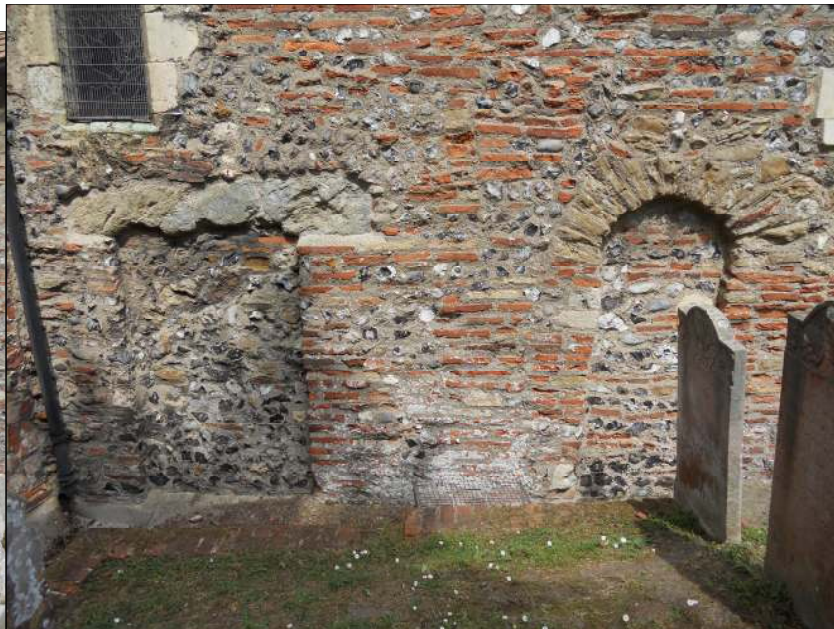
3. A closer view of both the openings in the south wall of the chancel.

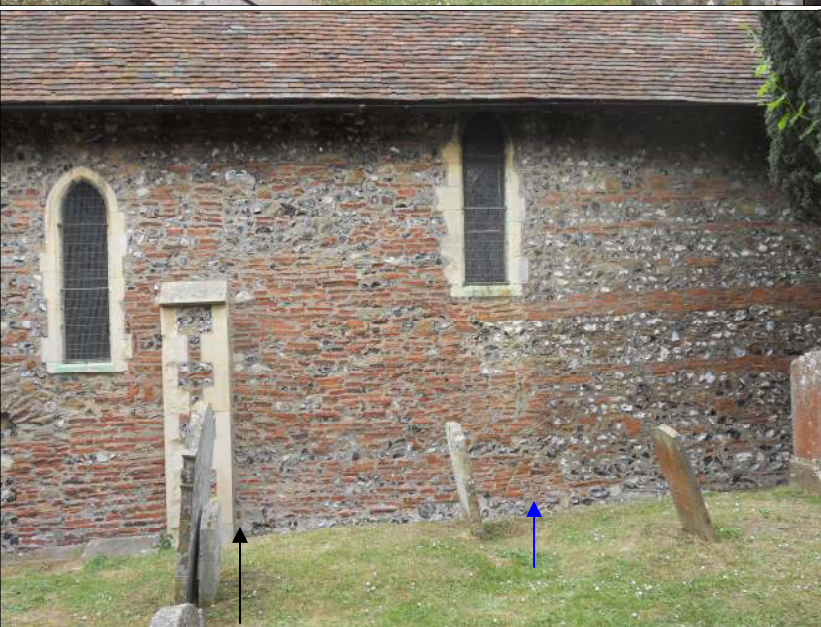
4. The interior of the chancel, the south wall, a good run of walling here lies exposed. The blocked round-headed doorway centre picture with the square-headed blocked opening to the right. The black arrow corresponds to that on the exterior in picture 1 (previous page) and picture 5 also.
