Church of St. Swithun. Headbourne Worthy, Hampshire.

All photos these pages are described viewed clockwise from top left.

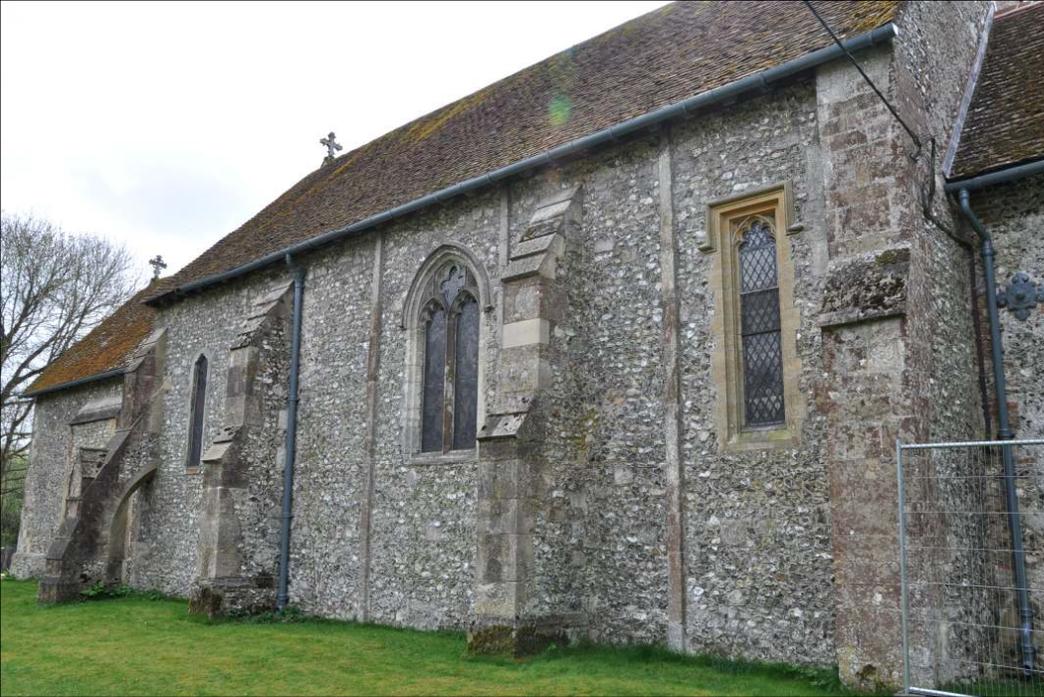
1. The north wall of the nave with the three extant pilaster strips (the centre strip being mostly hidden, in this view, by the medieval buttress). There is another strip on the S face of the chancel.
2. The long-and-short work of the NE quoin to the nave. Much of the fabric (including the Anglo-Saxon features) was rebuilt by G.E.Street in 1865-6 but original materials were reused in their original form.
3. The rood, larger than that at Breamore but more severely mutilated. Probably by order of Bishop Horne (1560-80) who is recorded by the VCH as having ordered the destruction of all Crucifixes in the Diocese of Winchester. The figures are rather more than life-size and are protected from the weather by the sixteenth century porch.

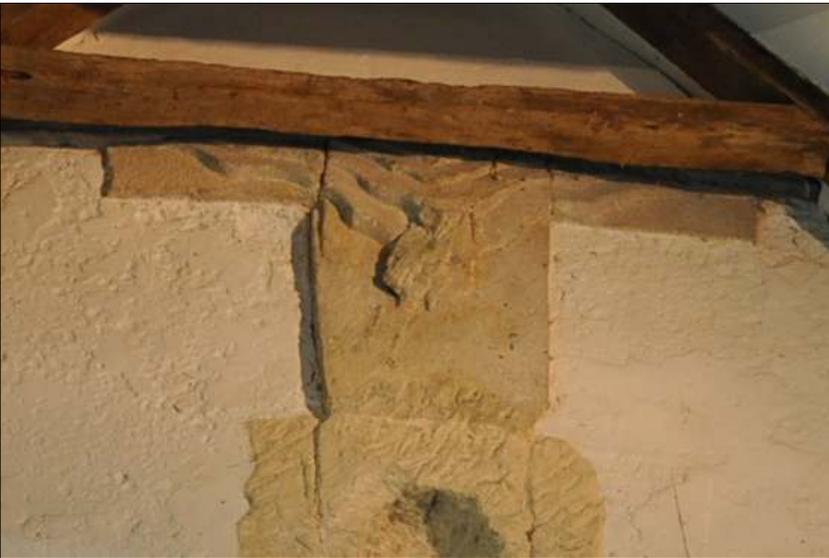
4. A detail of the rood, the hand of God descending from the clouds.
5. The west doorway to the porch and seen here its west face. It has square jambs of through stones (laid in 'Escomb' fashion) with plain chamfered bases and impost, and a semi-circular arch of a single square order, also of through-stones. On the W face the bases and impost are returned along the wall, and stopped against the outlining frame of square strip-work, which is carried up on either side of the jambs and round the head as a hood-mould. The builders of the 16th C porch have ruthlessly cut away part of the hood-mould to make way for the floor timbers of the upper room, and at some point the E face of the doorway has been rebated to hang a medieval door (source: H.Taylor).
6. Detail of (south) right-hand impost of arch seen in previous picture.
