This photograph is of part of the interior of **St. Nicholas church, Leicester**. The Anglo-Saxon window shown here is one of two remaining in the north wall of the nave. They are both contemporary with the walling and are of the Brixworth type and employ reused Roman bricks in the construction of the arched head. A date of circa 850 has been mentioned.

www.anglo-saxon-churches.co.uk

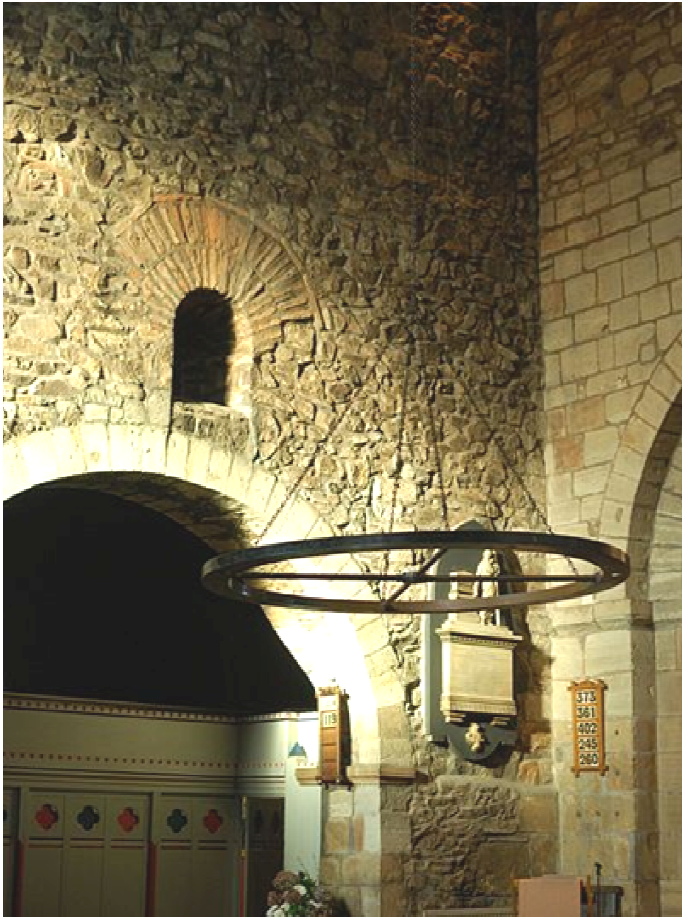
Looking carefully at the construction of the opening it seems there is some 'new' stonework filling immediately above the modern archway which partially cuts the window. If this is so then one would expect the sill of the window to have been lower than at present.
