St. Mary The Virgin, Norton, Co. Durham.

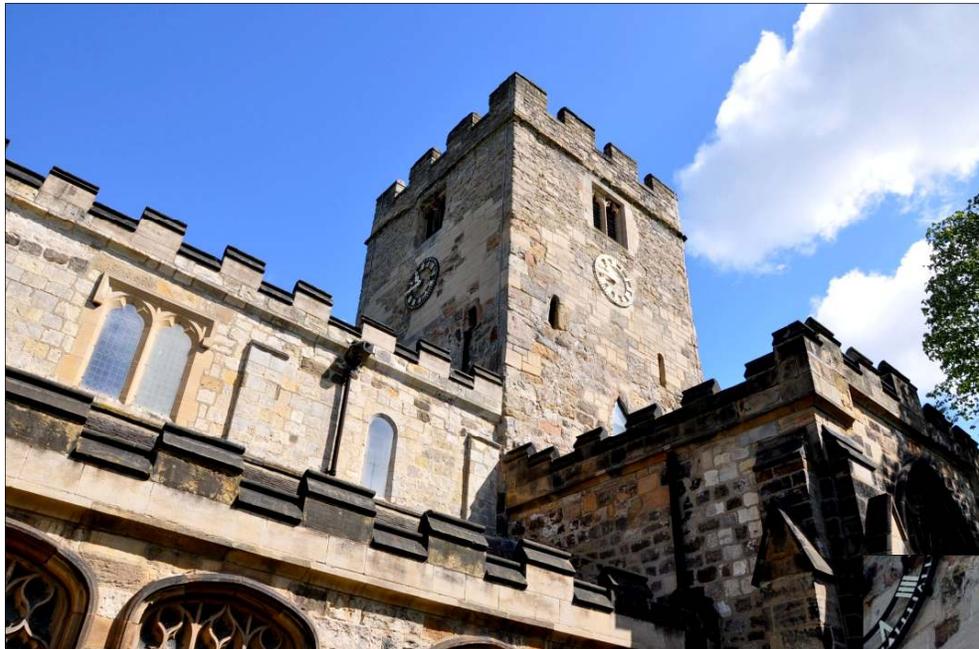
1. The central tower seen from the SW with the south transept running out to the right. Note the small Anglo-Saxon windows in the tower. These

would have cleared the original pitch of the transept roof.

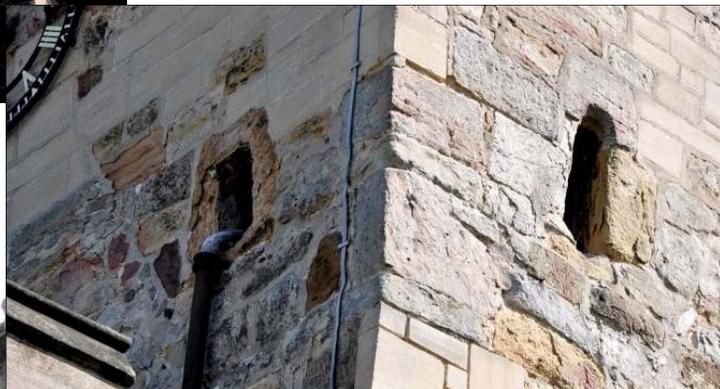
2. A closer detail from the same viewpoint of two windows, each being one of a pair.

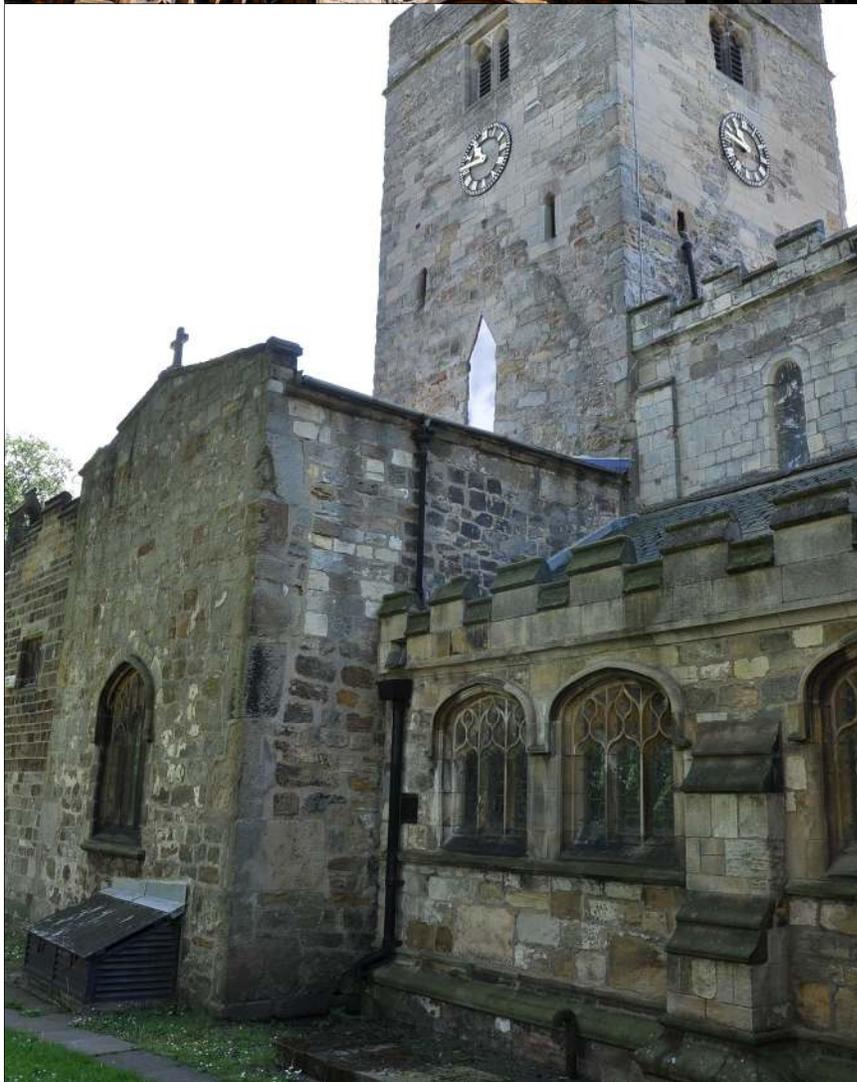
3. Seen from the NW the north transept is seen to the left. The triangular doorway to what was originally the transept roof space is seen nicely here and again the pair of small windows. This combination of three openings is common to all four faces of the tower. Note the massive size of the quoin stones of the transept which are indicative of pre-conquest work.

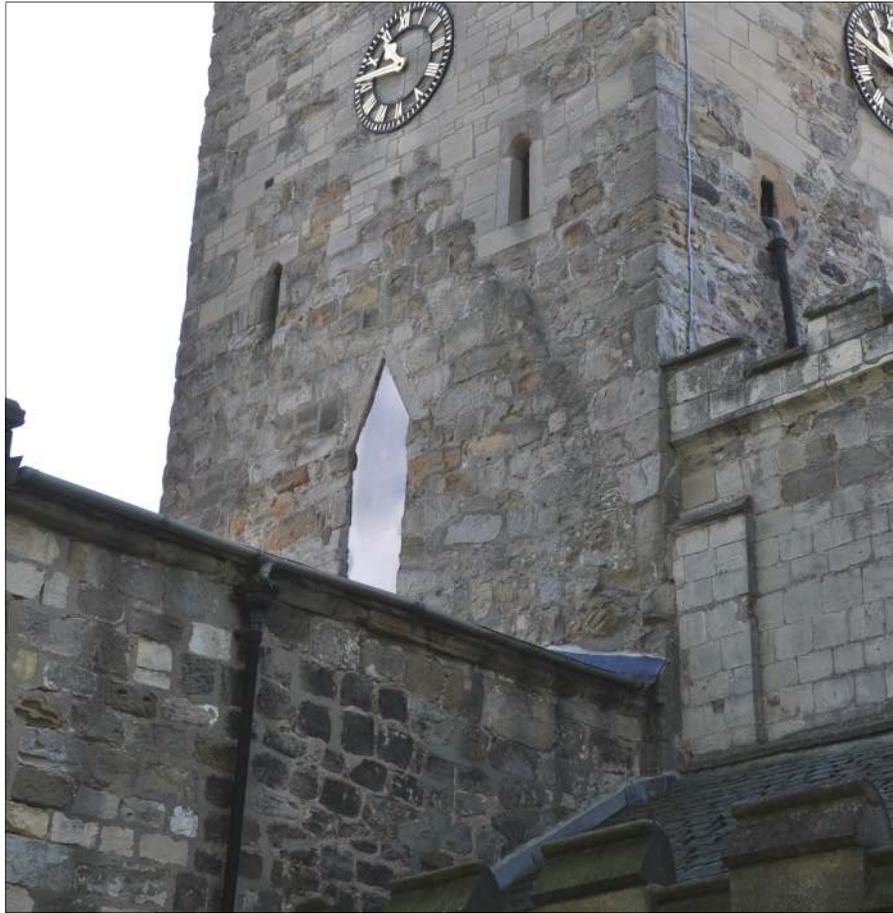
4. From the same viewpoint as picture 3, this closer view shows the triangular doorway to the original roof space of the north transept and with the outline of the original roof pitch clearly visible. Note that the walling under and around the old roof line on the tower matches that of the transept illustrating it was all one build.
5. The north transept from the NW and note again the massive stones of the quoins. In the same way as at Stow, Lincs, and Milborne Port, Somerset, and at Wimborne Minster in Dorset, the four subsidiary adjuncts are built so

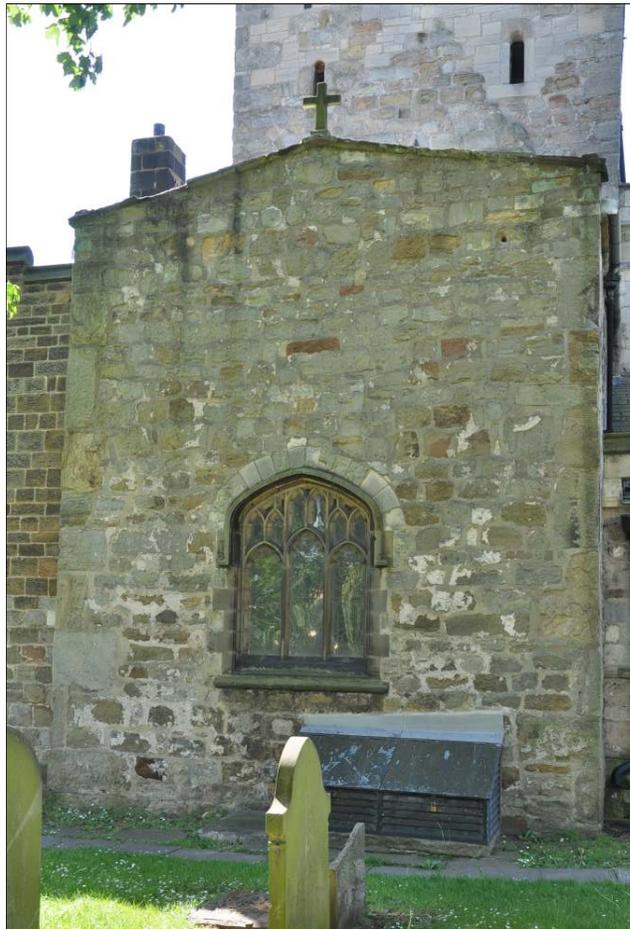
6. The north wall of the north transept with both quoins intact. The NW quoin is a strange mixture of stones set on their side and working upwards the next few courses repeat on that same side rather than being true side-alternate work. There are also long stones and the occasional short stone (as in long-and-short). All in all a very curious 'mixed' effect. We must remember that the Anglo-Saxon masons worked with the available stone to hand, they were not prepared at the quarry, at least not to any great degree, and certainly they were not pre-cut to a standard height ready to lay in true courses as in post-conquest times. In picture 5 look at the size of the quoin stone marked with the red arrow, its size is massive compared to its thinness. The black arrow some way above marks a short stone (as would be used in long-and-short work) below which there are four side set stones, though not necessarily alternate! The date of the building; Fernie puts the church at Norton in the first half of the eleventh century. He notes that the transept arches are off-set, unlike at Stow. At Milborne Port this off-set is repeated. The two arches that remain are of one square order with matching square imposts and double, or stepped, in height, as may be seen with the eastern archway at Barton-upon-Humber. Taylor notes that there is a possibility that the inner order has been removed to make the openings larger, certainly the archways do look slightly odd.
