Church of St. James, Selham, West Sussex.

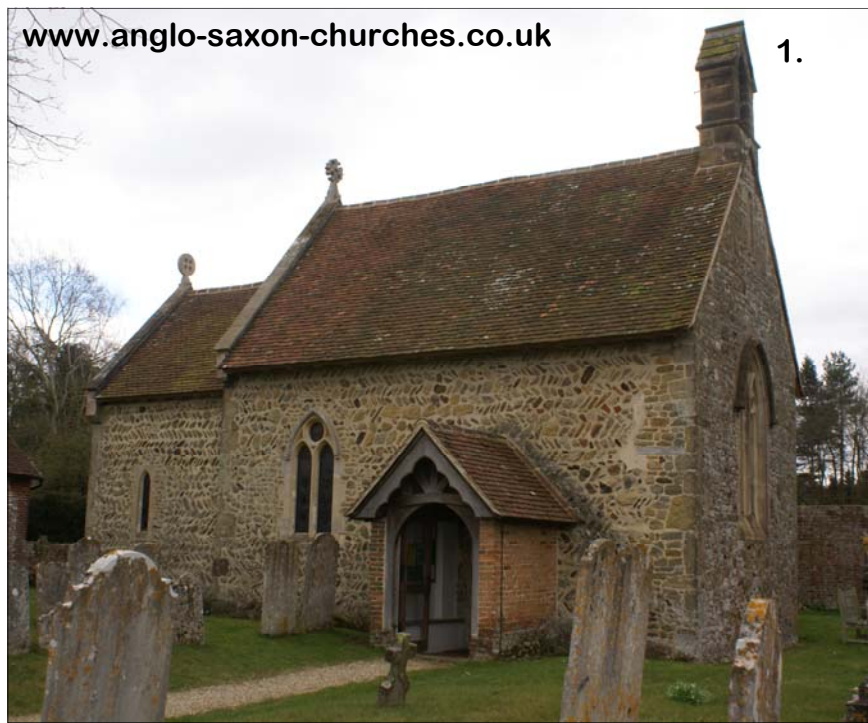
1. The church from the NW. Some evidence in the NW lower quoin of long-and-short work (the west wall rebuilt later).
2. Chancel arch from the nave.
3. Nave, and chancel beyond, the random rubble of the walling seen from the NW (that of the chancel partly coursed).
4. The N doorway to nave.
5. South capital, chancel arch, seen from the west (& see pic 7), scrolls and monsters.
6. North capital, chancel arch - both Saxon and Roman, the impost is a reused Roman fragment, obvious in its (truncated) classical section (see Taylor & Taylor).
7. South capital seen again here, strange in its 'tiered' top heavy effect, it is actually deeper in height than its sister (possibly reusing existing worked stones).
