## Anglo-Saxon church at Trowbridge, Wiltshire.

Excavations have been carried out at various times since the 1960's on the site centred on the area of the now vanished castle at Trowbridge. The foundations of an Anglo-Saxon church (described as "structure 17" in the excavations) have been found and largely excavated in 1977. This church would have dated to the late Anglo-Saxon era when the site was a fortified manor.

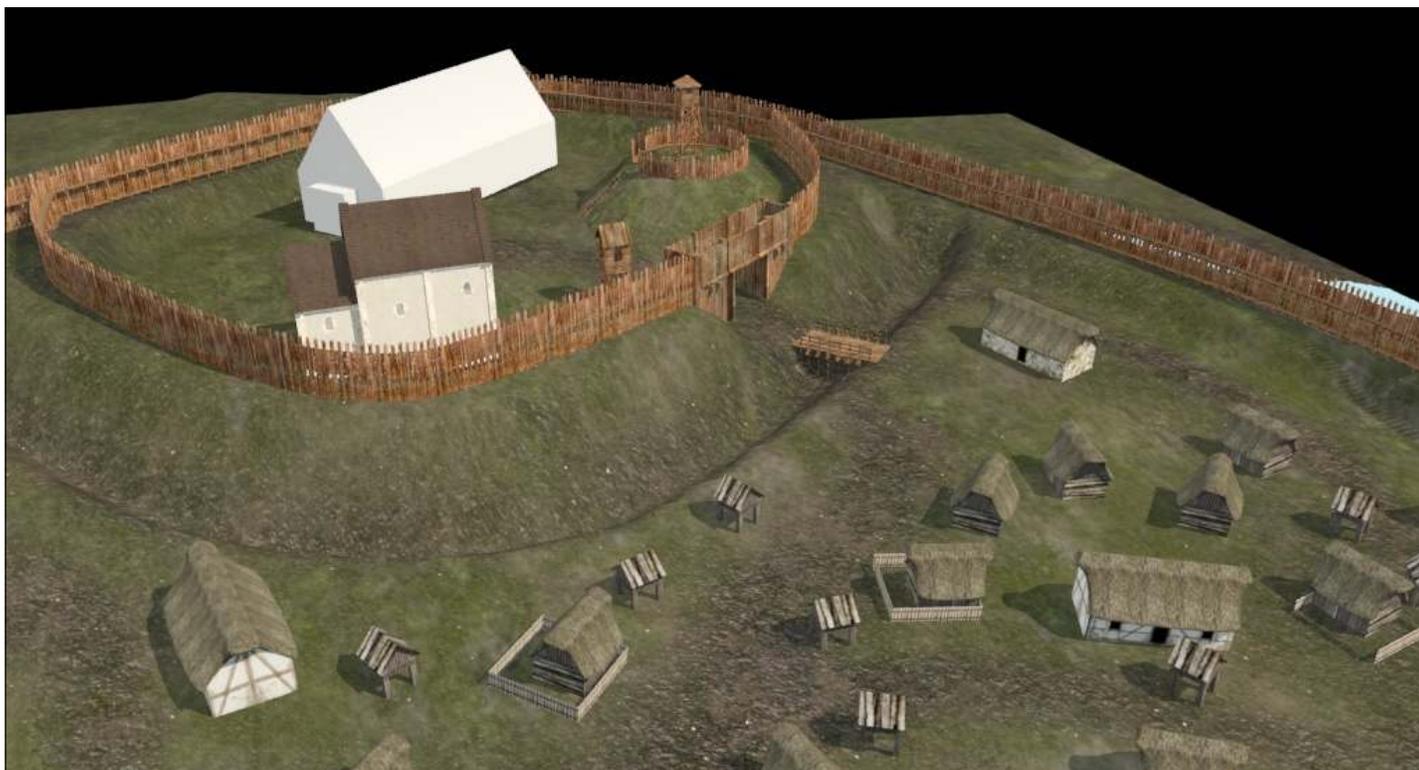
The top photograph shows a computer generated general view of the inner bailey, as it might have looked circa 1080, and with the pre-conquest church up against a timber palisade with a possible hall behind. To the right is the area of the outer bailey.

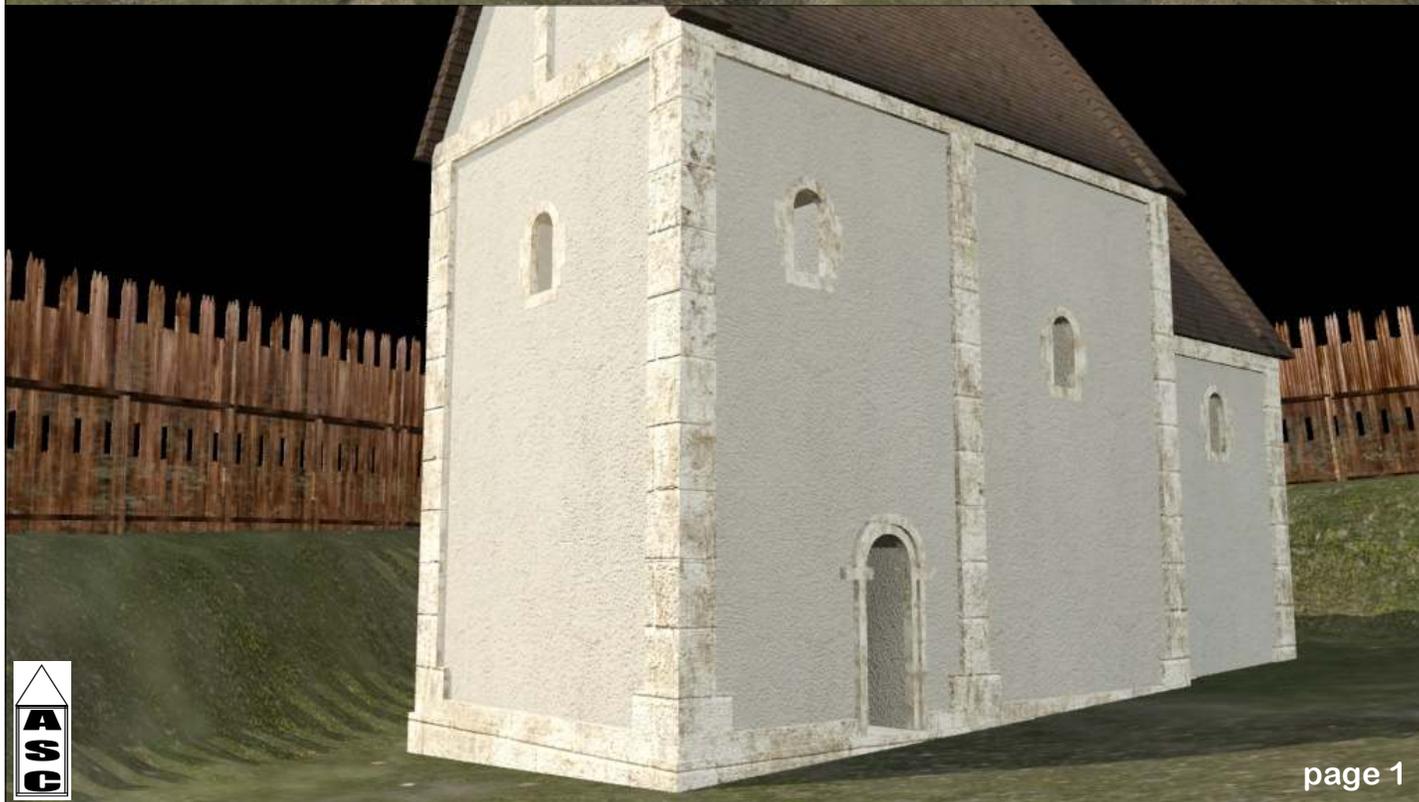
The bottom photo is the church "restored" as it may have looked, seen from the south-west. Note the cut-back pilaster strips and quoins which would be usual for the period when the church was built. For dimensions of the church see page 2.

I am grateful to Matthew and Rachael, who are engaged with "Preserve Our Past", and in conjunction with Trowbridge Museum, for allowing me to reproduce the photos of the reconstruction (shown on pg 1). My sketches and dimensions (based on data extracted from excavation) with related notes were used to reconstruct the appearance of the church.

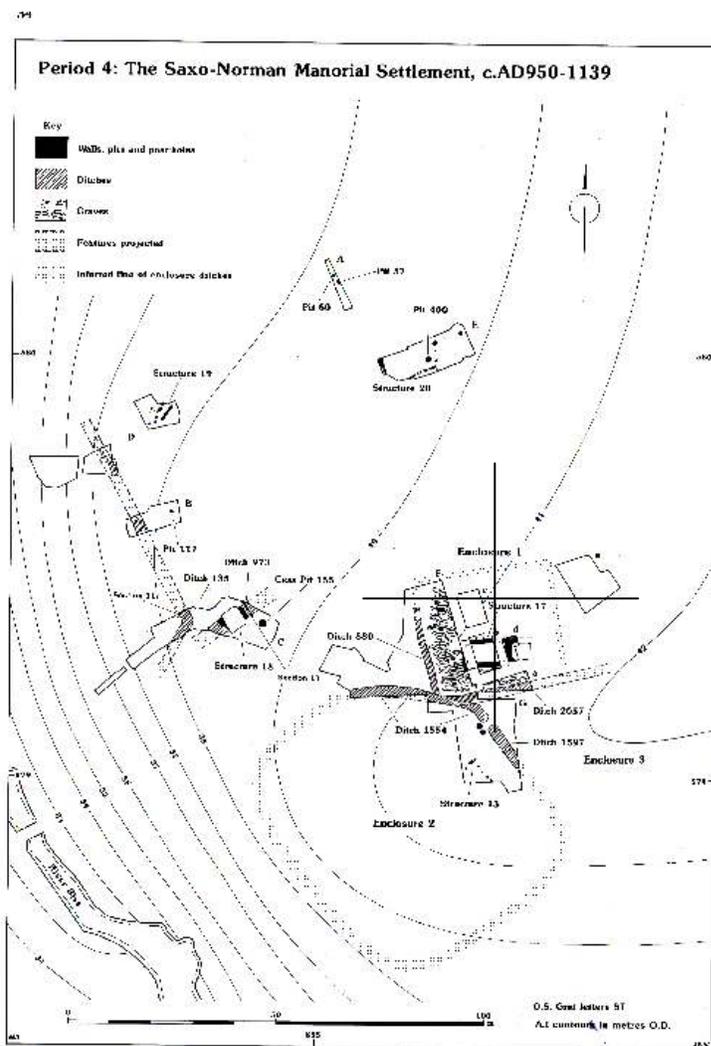
Figure 12 Period 4: the Saxo-Norman manorial settlement, c. AD 950-1139

A file is reproduced here with data extracted from excavations carried out. It shows the general area and with the pre-conquest church site picked out by a cross which fixes the centre of the building. The post-conquest motte is immediately to the SW of the church.
