Church of St Thomas of Canterbury, Warblington, Hampshire.

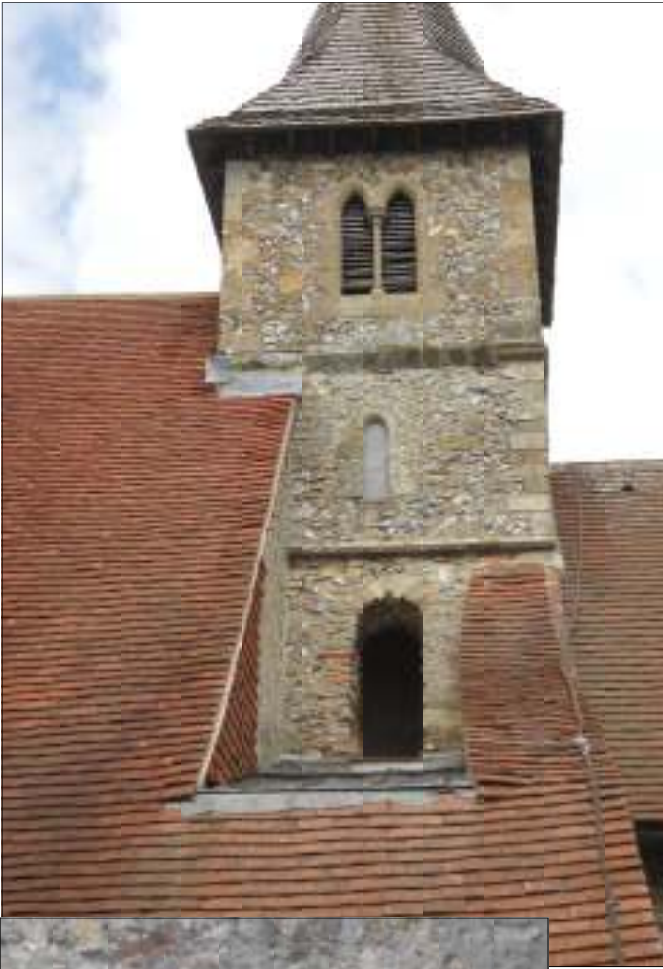
1. The tower seen from the south.
2. A closer view of the south doorway.
3. The north doorway.

Sandwiched between nave and chancel is a pre-conquest tower measuring some nine feet square. Originally a west tower the ground story was swept away when medieval archways were inserted at ground level opening up and linking later nave to chancel. The top story is a later medieval addition. The interesting features are the north and south late Anglo-Saxon doorways viewed externally between 'troughs' in the aisle roofs. These doorways are built with rough rubble jambs cut straight through the wall.
