# The Introduction and Use of Masons' Marks in Romanesque Buildings in England

By JENNIFER S. ALEXANDER

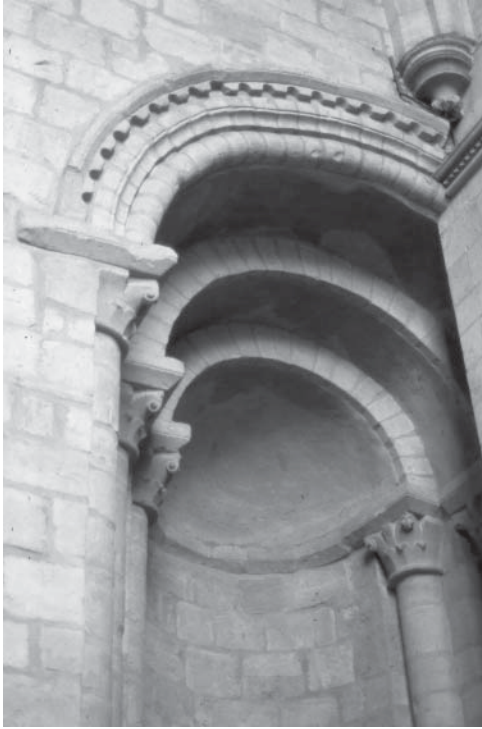
FIG. 1

Lincoln Cathedral NW. front, detail of N. niche.  
*Photograph: J. S. Alexander.*

Two other cathedral sites present considerably larger areas for study: Lincoln's W. front and Winchester's crypt and transept. Although both contain 12th-century work, the stone-treatment is sufficiently different to identify the earlier work. Remigius (d. 1092) began the early work at Lincoln after 1072, when the *cathedra* was moved from Dorchester on Thames (Oxfordshire).<sup>12</sup> Unweathered masonry from this period can be seen on the return N. and S. walls of the W. front. The stone surfaces are in excellent condition because they have been inside the building since the screen facade was added in the 13th century (Fig. 1). Stone taken to a higher degree of finish was reserved for arches and openings and it is here that the masons' marks are found (none is on the main walling stone). On the arch to the large niche on the SW. corner, and on the arched openings to the wall passages in the W. block, every arch stone is marked. The marks on the SW. niche are all the same, a simple saltire cross placed on the outer edge of the moulding, and may be assembly marks, used to indicate the arch on the W. front to which the stones belong.<sup>13</sup>

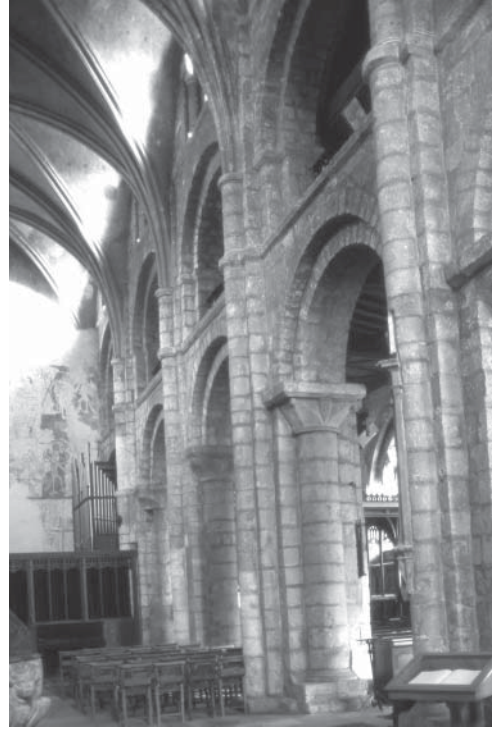
FIG. 2

Blyth Priory, nave S. arcade from the W.  
*Photograph: J. S. Alexander.*

it a case of ‘early Norman grimness’ (Fig. 2).<sup>15</sup> Founded in 1088, building work on the priory seems to have started immediately. Since the only surviving parts are the nave and fragments of the S. transept, work must have progressed rapidly for the nave still to be a late 11th-century construction.<sup>16</sup> Masons’ banker marks are present on the nave piers, to a lesser extent on the outside walls, and in the upper parts of the walls above the later vault (Fig. 3). Numbers of marks are not large: about 20% of the walling stone above the nave vault is marked, a slightly higher proportion than we see in other early Norman buildings.

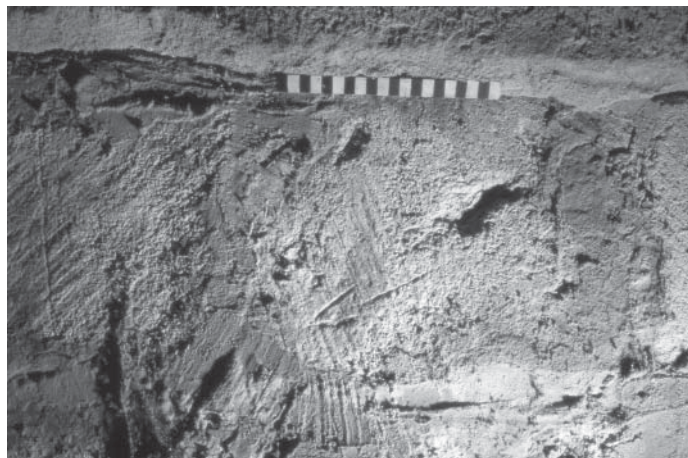
FIG. 3  
Blyth Priory, mason's mark on  
stone above later nave vault.  
*Photograph: J. S. Alexander.*

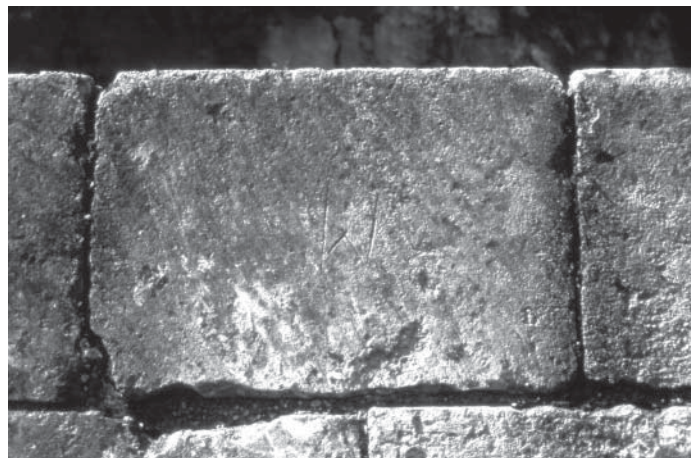
FIG. 5  
Roche Abbey, mason's mark  
on nave N. aisle wall.  
*Photograph: J. S. Alexander.*

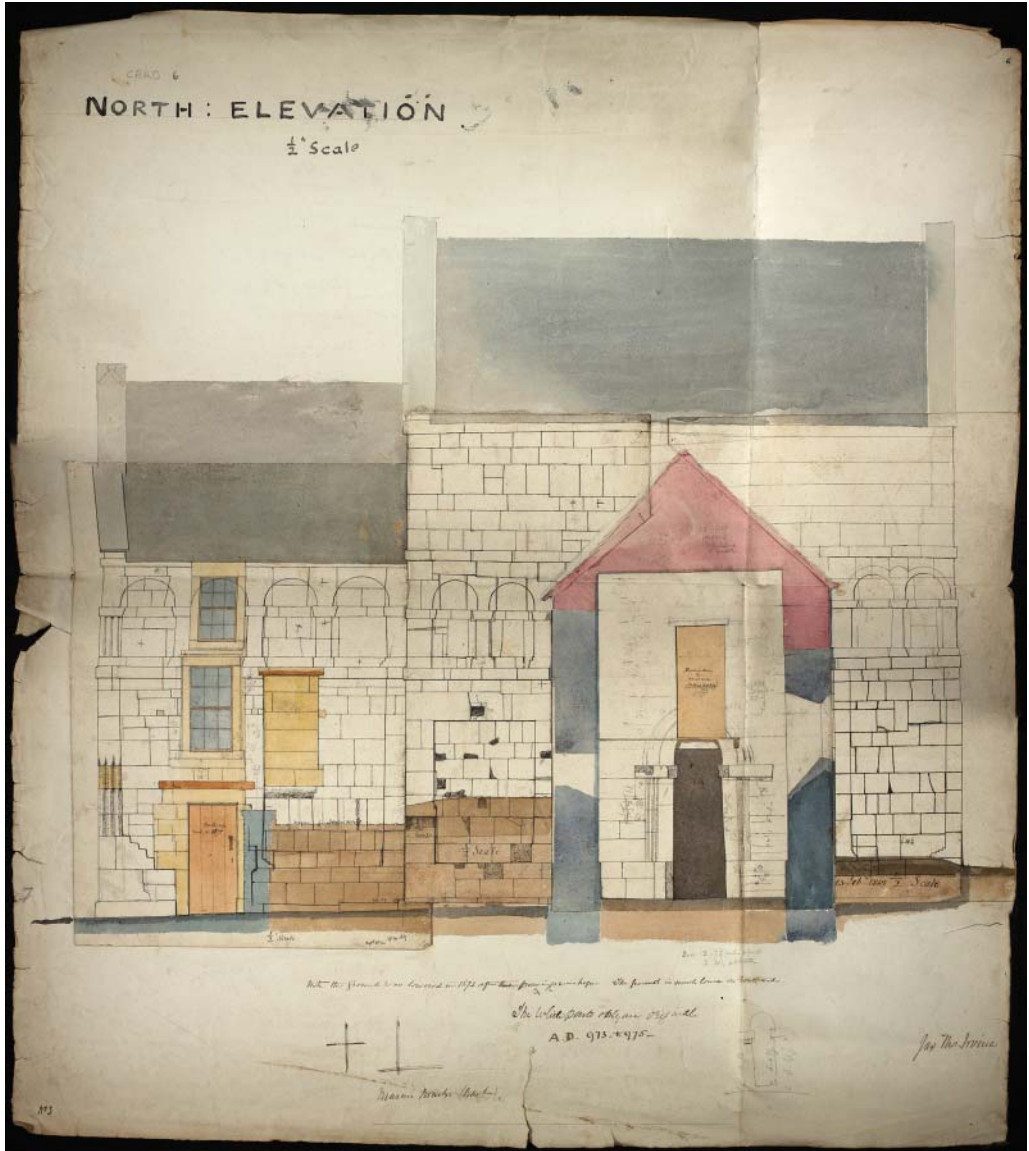
FIG. 6

Bradford on Avon St Lawrence, scale drawing by J. T. Irvine of the N. side of the church before restoration, 1869. Photograph: Bathintime, reproduced by permission of the Trustees of the National Museums Scotland.

Masons' banker marks are, however, present on the one surviving ashlar church from the Pre-Conquest Period, St Lawrence's, Bradford on Avon (Wiltshire), now accepted as being a work of the very early 11th century. Its building relates to a grant to the nuns of Shaftsbury to provide a refuge from the Vikings in 1001.<sup>42</sup> The stone cutting is of a very high standard and the presence of two large-scale angel sculptures on the interior emphasises the building's high status. The stone is Ancliff Oolite, quarried locally.<sup>43</sup> Several of the ashlar blocks on both the interior and exterior are marked, some recorded by J. T. Irvine in 1869 on measured drawings done before the building's restoration.<sup>44</sup> Remarkably, the marks that Irvine recorded on the exterior are mostly still visible, although one block at the E. end of the chancel N. wall has spalled and the surface detail is no longer clear. The marks are simple two-line crosses and occur in seven locations on the upper parts of the N. walls of the nave and chancel. Most marks are on the plain stonework but one is centrally placed on the blind arcading, and a second, shaped like an inverted 'T' is immediately above on the spandrel of the chancel W. bay (Fig. 6).

Two of Irvine's drawings of the interior indicate the presence of banker marks by notes in the margins of the drawings but do not place the marks on

the walls. These are the same crosses shown on the exterior, located on the W. and N. interior walls of the N. porticus. They are also present, together with some lightly inscribed saltire crosses, on the interior of the nave N. wall. The depth of cutting of the marks varies; some are quite shallow and it is possible that weathering has destroyed others. Irvine recorded no marks on the doorways
