Church of the Holy Trinity, Bosham, West Sussex.

Bosham Church.

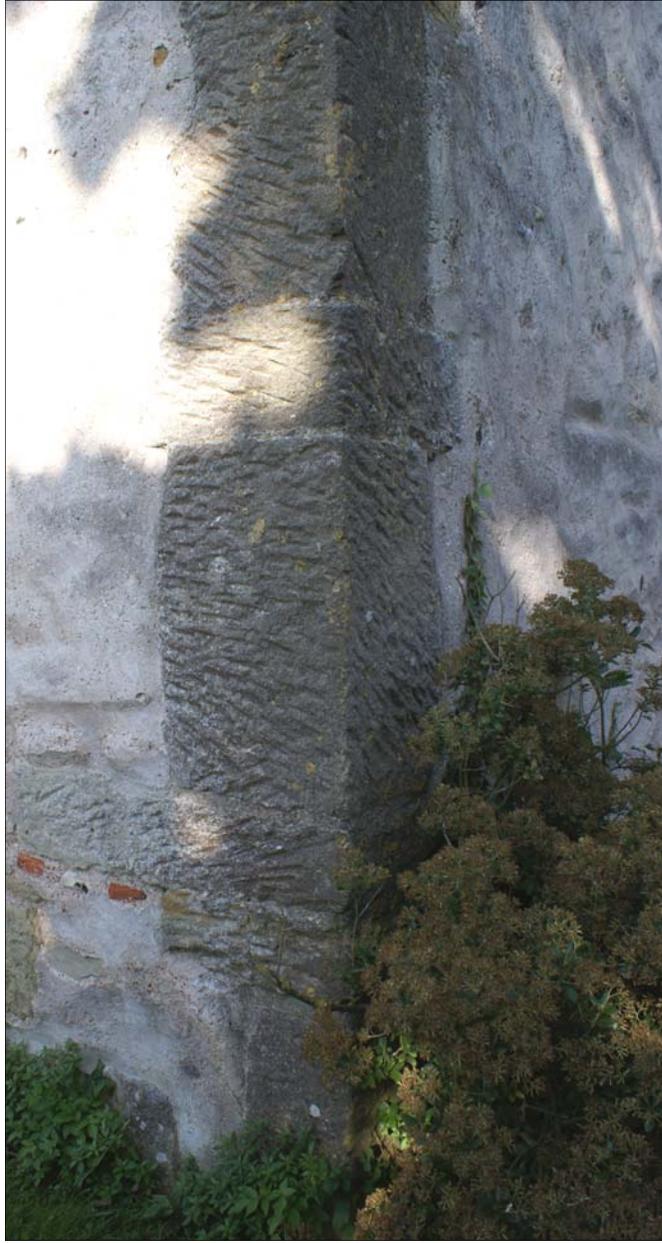
1. SW quoins, tower; note the Roman tooling on these reused stone blocks.
2. North face of tower.
3. Topmost window opening, tower, west face, note shaft mid-way in wall thickness.

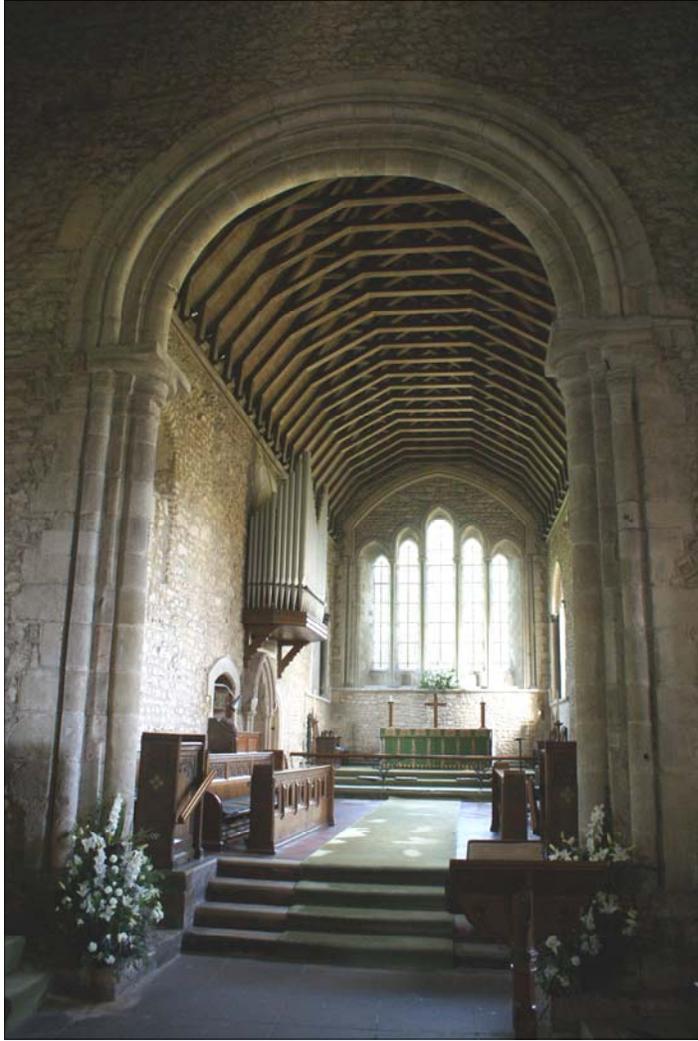
1. Chancel arch viewed from the nave.
2. Chancel arch, north capital viewed from the chancel.
3. Chancel arch north capital, from below. Possible re-use of Roman stonework (reuse of Roman stone detail being common and in this case possibly ex. the nearby Fishbourne Roman Palace).
4. Archway to tower, situated in east wall of tower, viewed from nave.
