All Saints Church. Laughton-en-le-Morthen, West Riding, Yorkshire.

At this church are important pre-conquest remains which may once have formed a complex of western chambers.

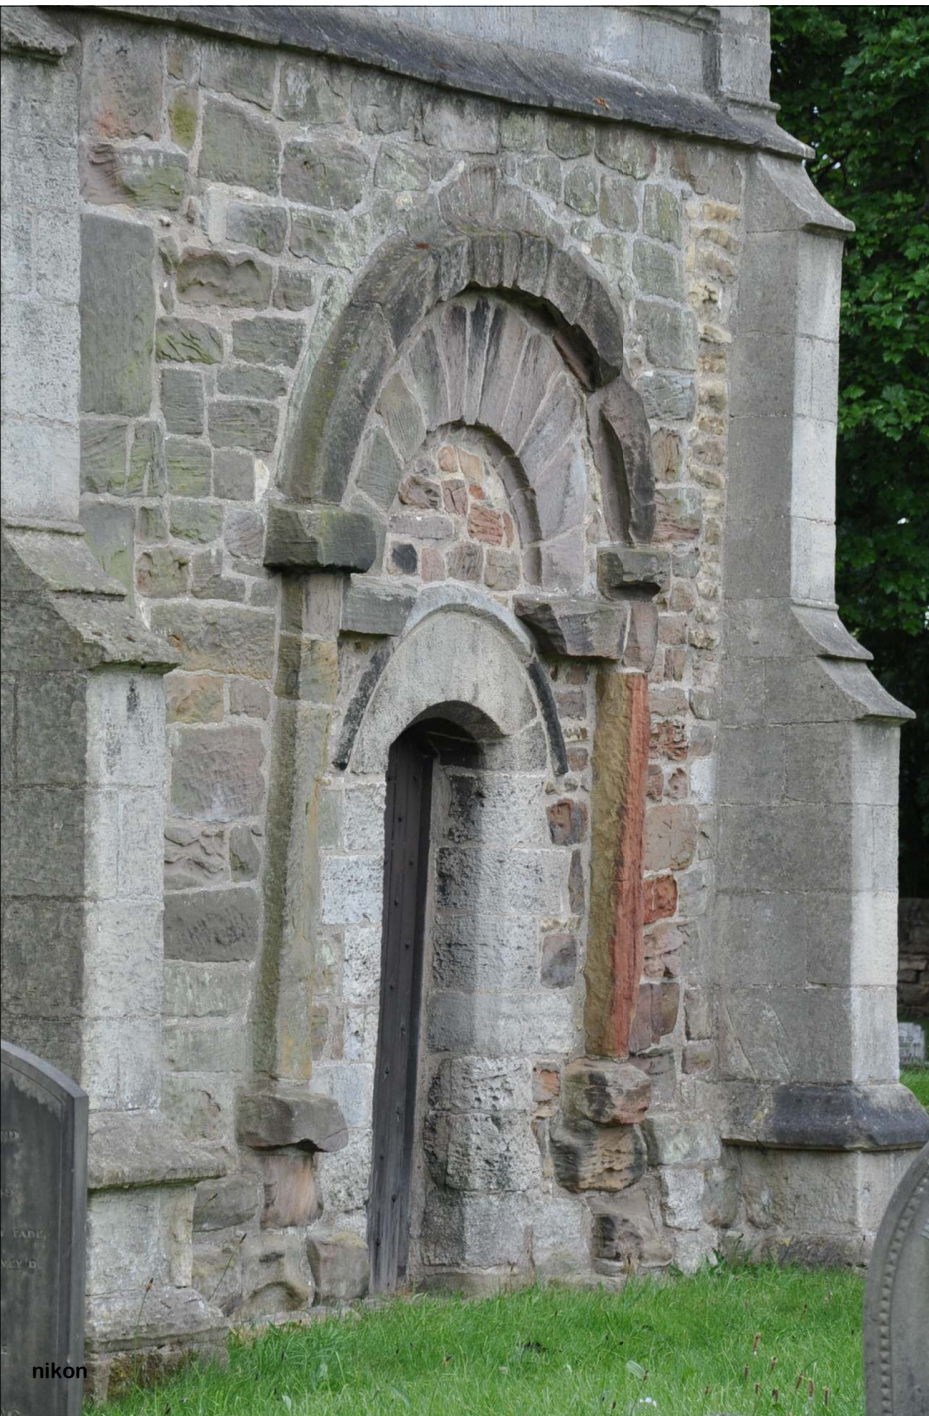
1. The remaining north wall of a west porticus of Anglo-Saxon date with its impressive doorway which has unfortunately been subjected to the insertion of a later non-descript medieval doorway. This has resulted in the cutting away of the impostes at an angle and the removal of the jambs. This view shows the extent of the wall being out of vertical. H.Taylor noted that the surviving Anglo-Saxon fabric was either a porch or chapel measuring about 17.5 feet (east to west) and he remarked upon the similarity between this example and evidence at Brixworth and Monkwearmouth for (now vanished) lateral chambers at the west.

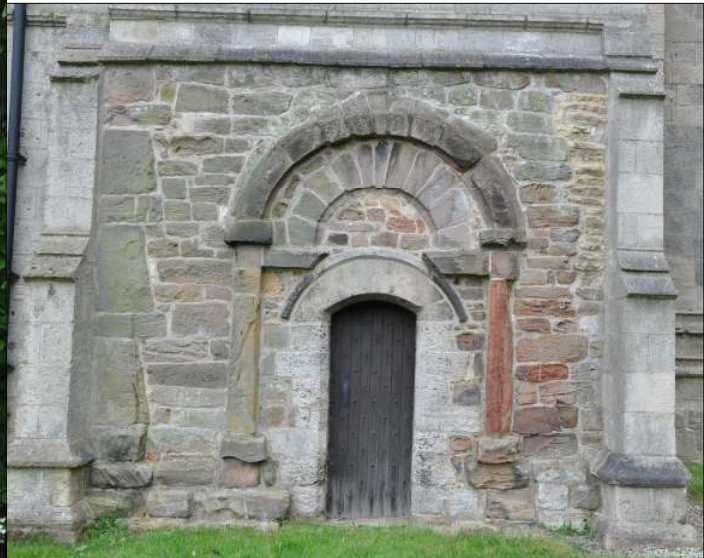
2. Again, but seen square on from the north. Note the long-and-short work of the NE quoin (whereas the right hand NW quoin is masked under the later buttress).

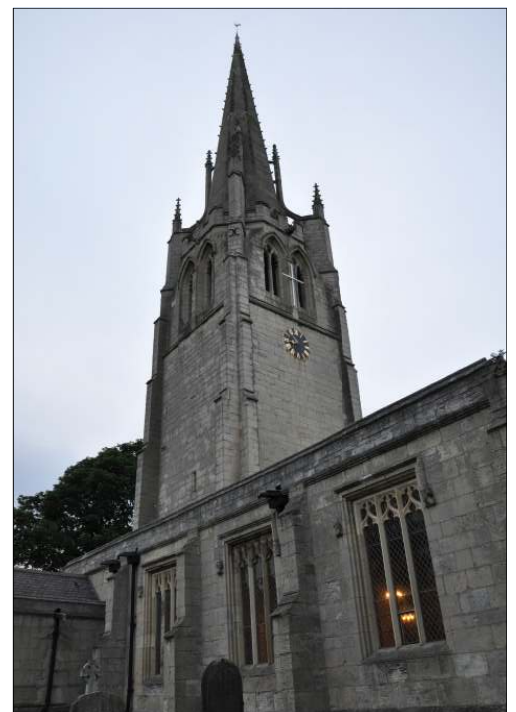
3. A general view of the church, showing the fine tower with its spire rising to a height of 185 feet. There is no indication from this view (taken from the SE) that there are important remains of pre-conquest date in the church (which was considerably rebuilt in Norman days, and that in its turn ruined, to be partly rebuilt in 1377).

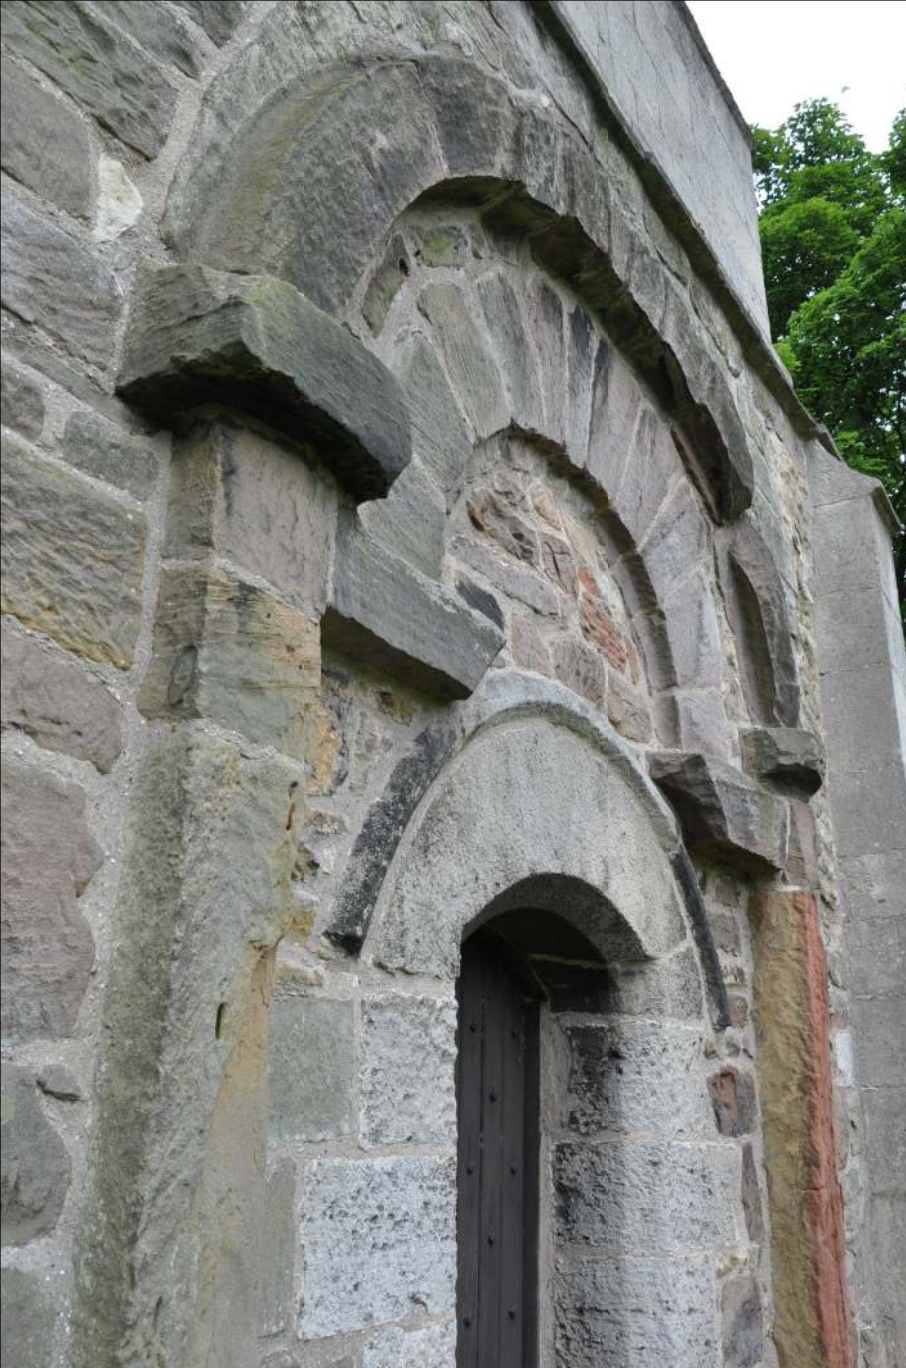
4. A closer view giving a "3D" impression of the style and construction of the north doorway.

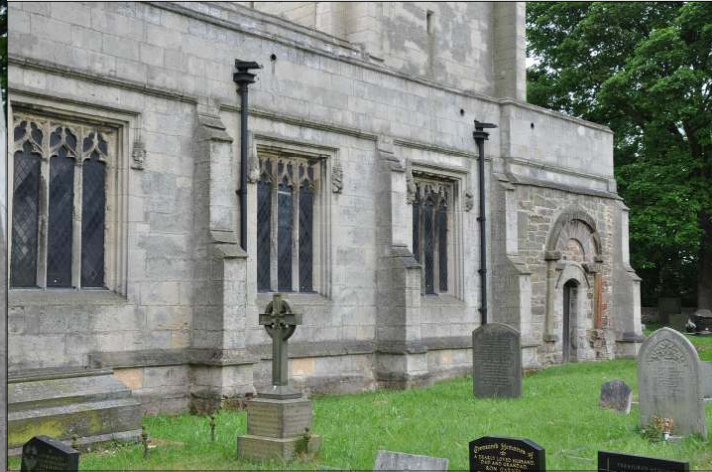
5. A general view of the medieval north aisle showing how the remains have been adapted and included in the run of that aisle westwards.

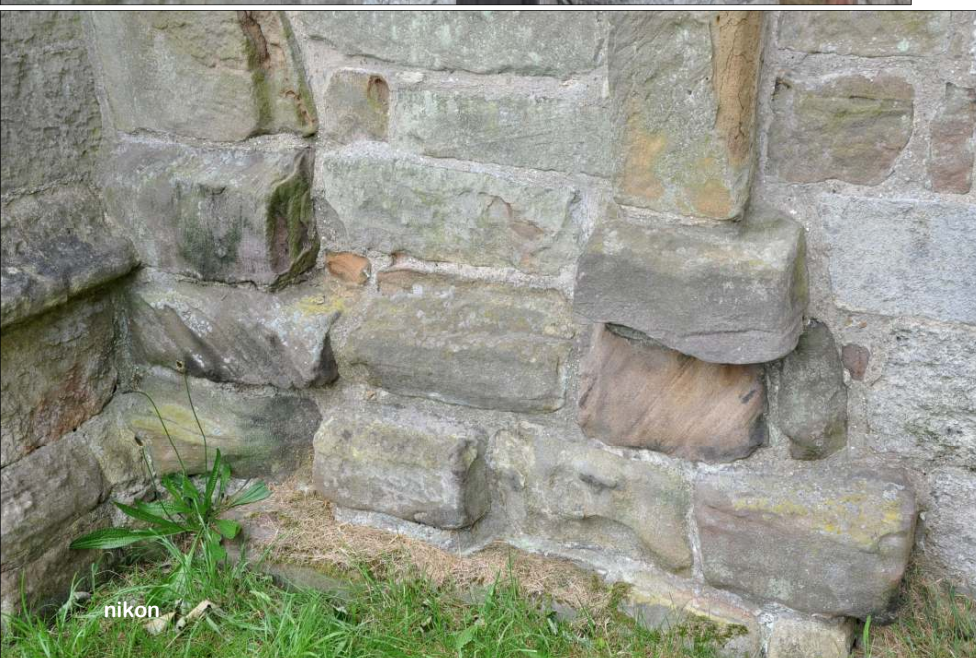
6. A detail of the stop at the foot of left hand (eastern) pilaster and to its left the base of the long-and-short work of that quoin. Note a part of the plinth with its protruding stones.
